UNITED STATES ENVIRONMENTAL PROTECTION AGENCY

SUBJECT: Inspection Report Transmittal to Ledgeview Farms, LLC

On April 9, 2015, EPA conducted an inspection of your facility, Ledgeview Farms in De Pere, Wisconsin. The purpose of the inspection was to evaluate compliance with the Clean Water Act (CWA) and Administrative Order V-W-13-AO-22. Ledgeview Farms is a large Concentrated Animal Feeding Operation (CAFO) as defined in 40 C.F.R. § 122. During the inspection, we observed violations of the CWA and Administrative Order. The CWA and Order requires you to immediately cease all unauthorized discharges.

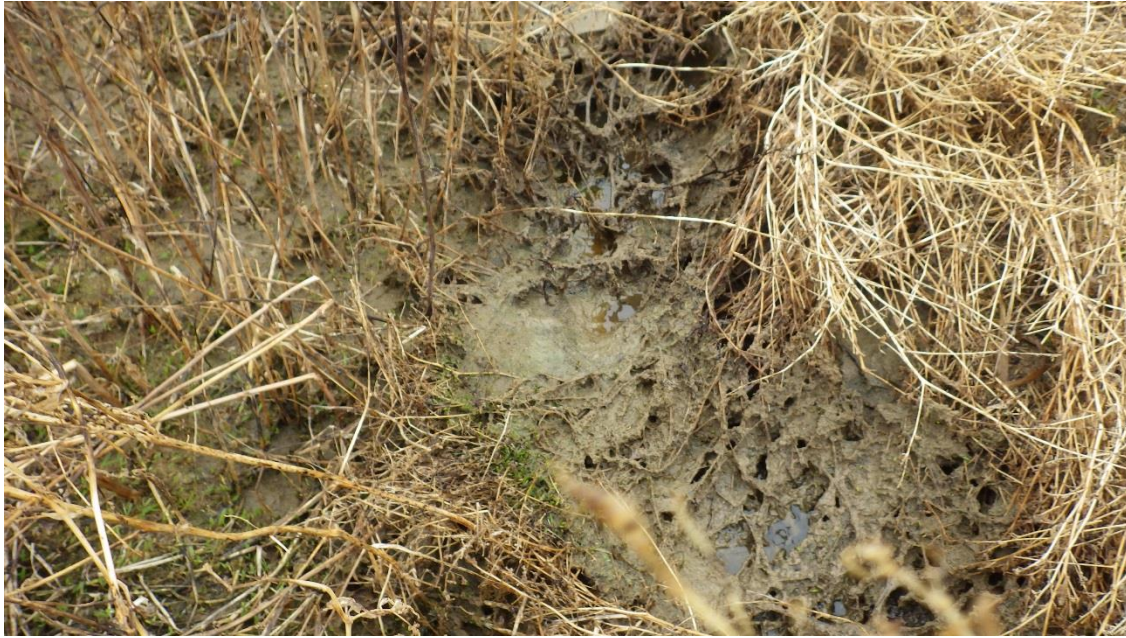
238: RIMG0247

Description: Manure and process wastewater flowed north toward the borrow area from the New Barn and cattle walkways between the New Barn and the barn west of the New Barn.

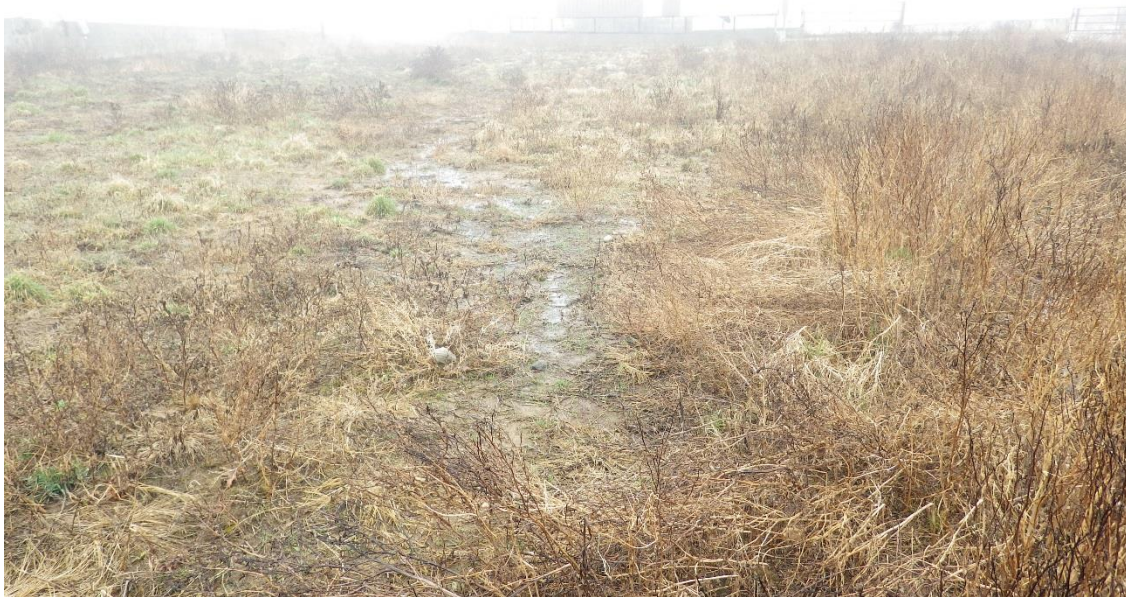
239: RIMG0248

Description: Manure and process wastewater flowed north toward the borrow area from the New Barn and cattle walkways between the New Barn and the barn west of the New Barn.

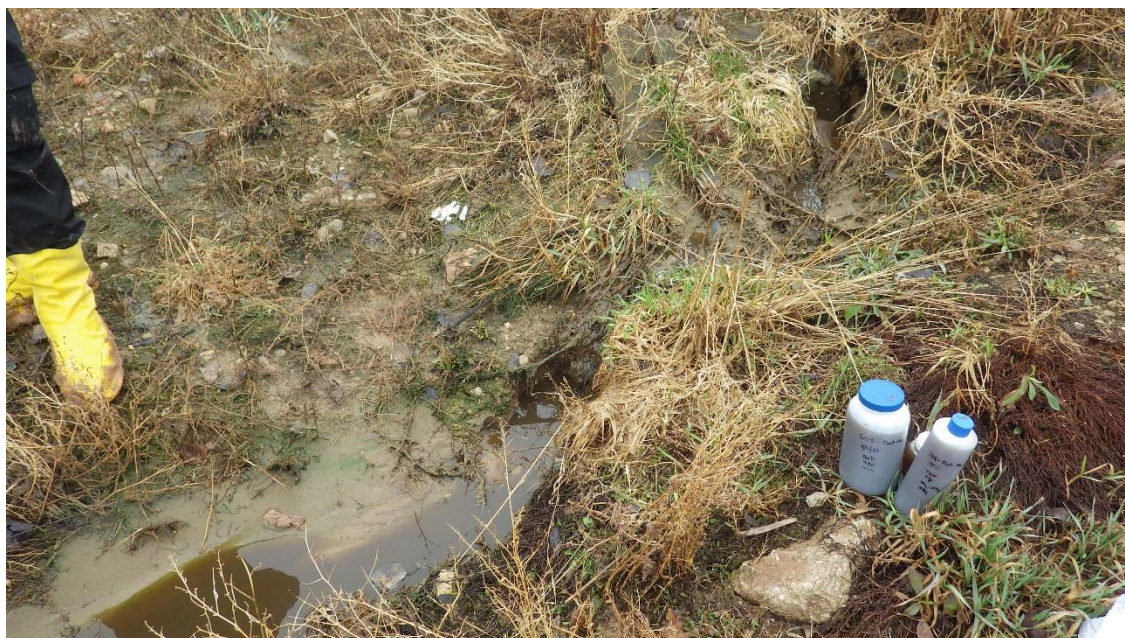
240: RIMG0249

Description: Manure and process wastewater flowed north toward the borrow area from the New Barn and cattle walkways between the New Barn and the barn west of the New Barn.

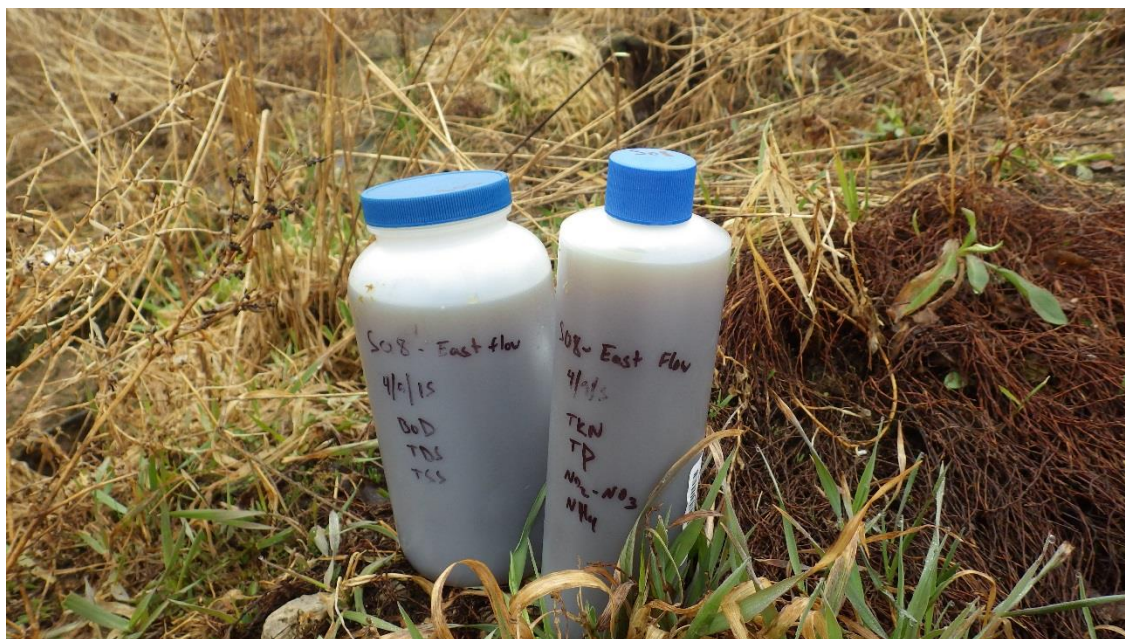
241: RIMG0250

Description: Sample S08 was taken at 1:12 p.m. of manure and process wastewater in a pathway emanating from the New Barn and cattle walkways between the New Barn and the barn west of the New Barn.

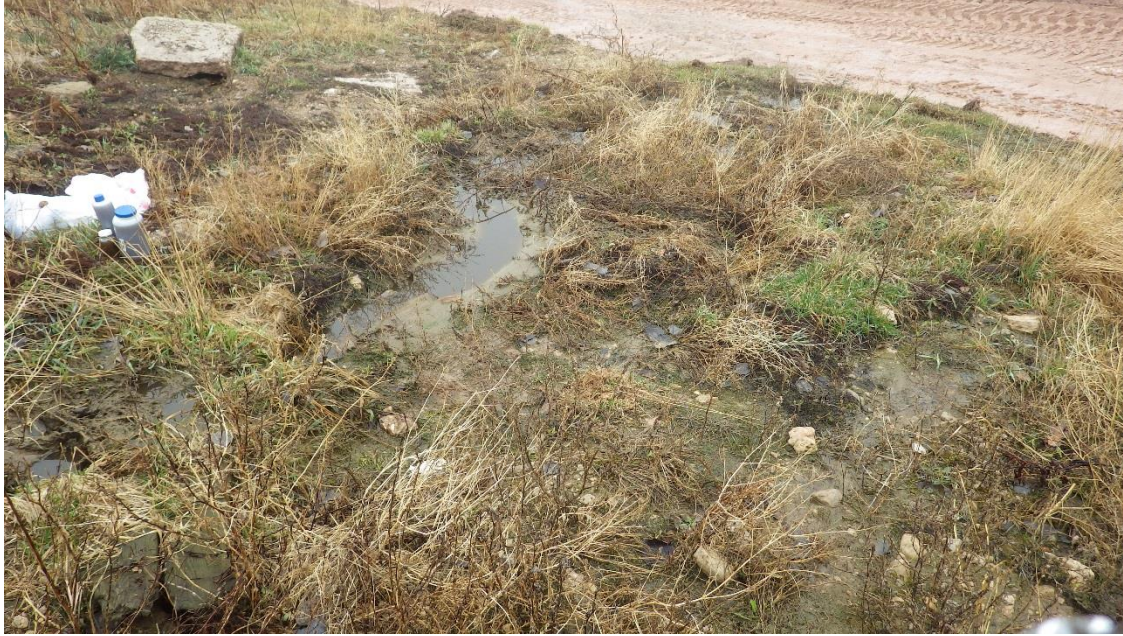
242: RIMG0251

Description: Sample S08 was taken at 1:12 p.m. of manure and process wastewater in a pathway emanating from the New Barn and cattle walkways between the New Barn and the barn west of the New Barn.

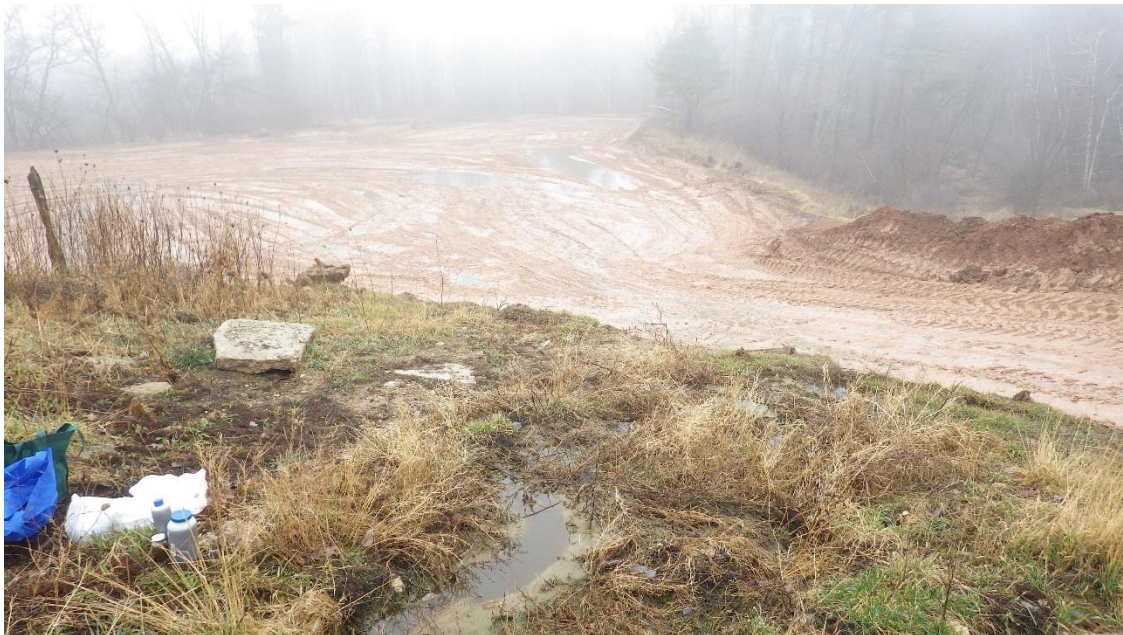
243: RIMG0252

Description: Sample S08 was taken at 1:12 p.m. of manure and process wastewater in a pathway emanating from the New Barn and cattle walkways between the New Barn and the barn west of the New Barn.

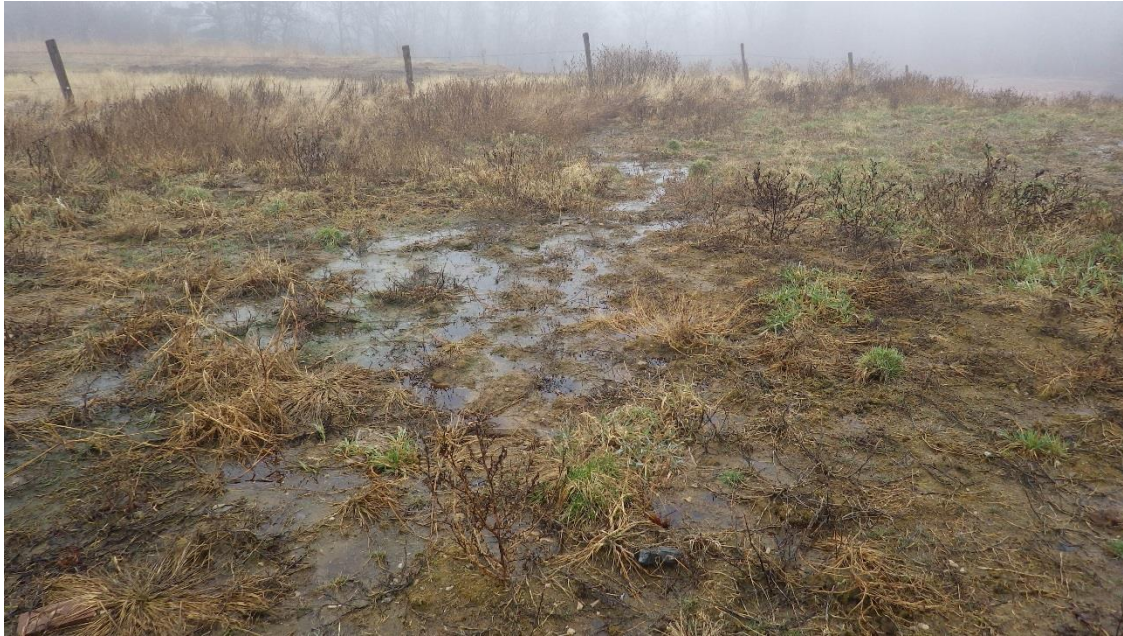
244: RIMG0253

Description: Sample S08 was taken at 1:12 p.m. of manure and process wastewater in a pathway emanating from the New Barn and cattle walkways between the New Barn and the barn west of the New Barn.

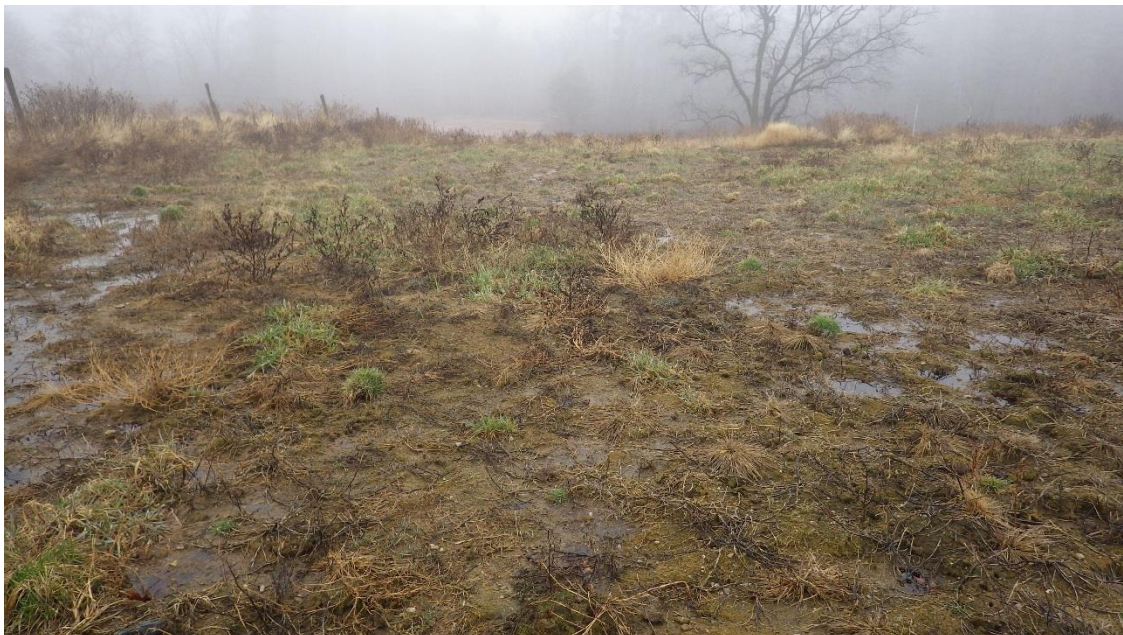
245: RIMG0254

Description: Manure and process wastewater flowed north toward the borrow area from the New Barn and cattle walkways between the New Barn and the barn west of the New Barn.

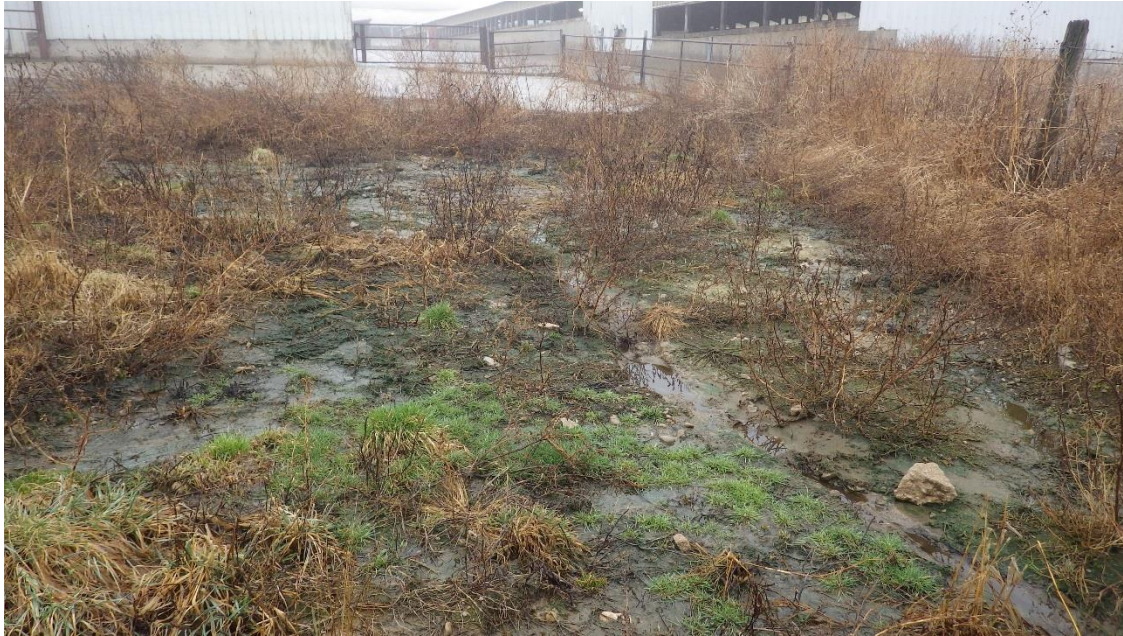
246: RIMG0255

Description: Manure and process wastewater flowed north toward the borrow area from the New Barn and cattle walkways between the New Barn and the barn west of the New Barn.

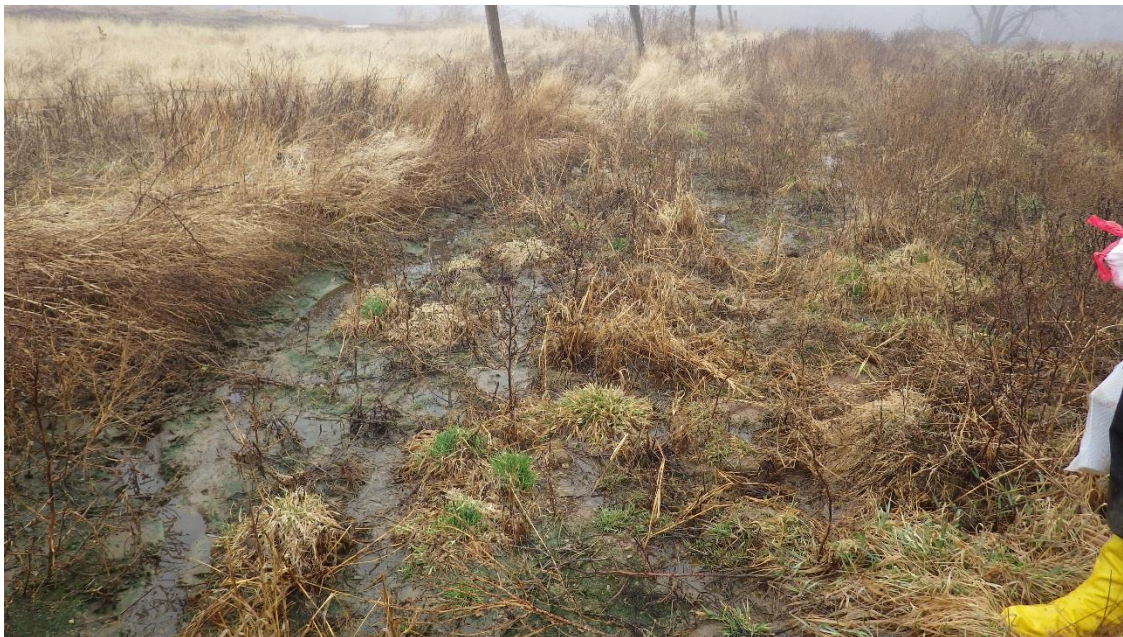
247: RIMG0256

Description: Manure and process wastewater flowed north toward the borrow area from the New Barn and cattle walkways between the New Barn and the barn west of the New Barn.

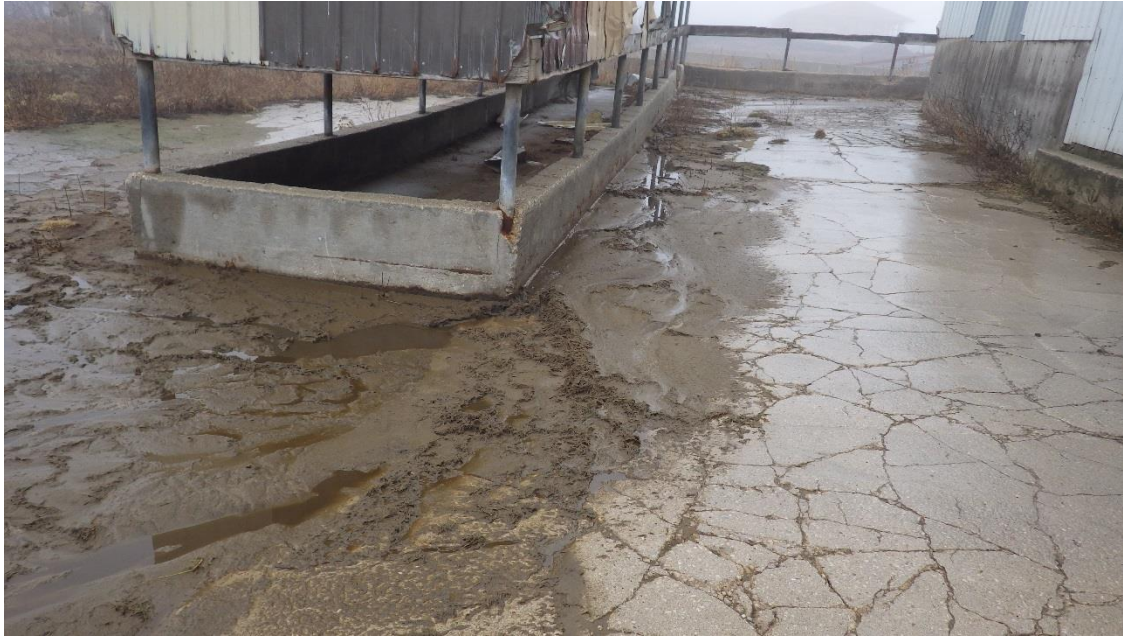
248: RIMG0257

Description: Manure and process wastewater flowed north toward the borrow area from the New Barn and cattle walkways between the New Barn and the barn west of the New Barn.

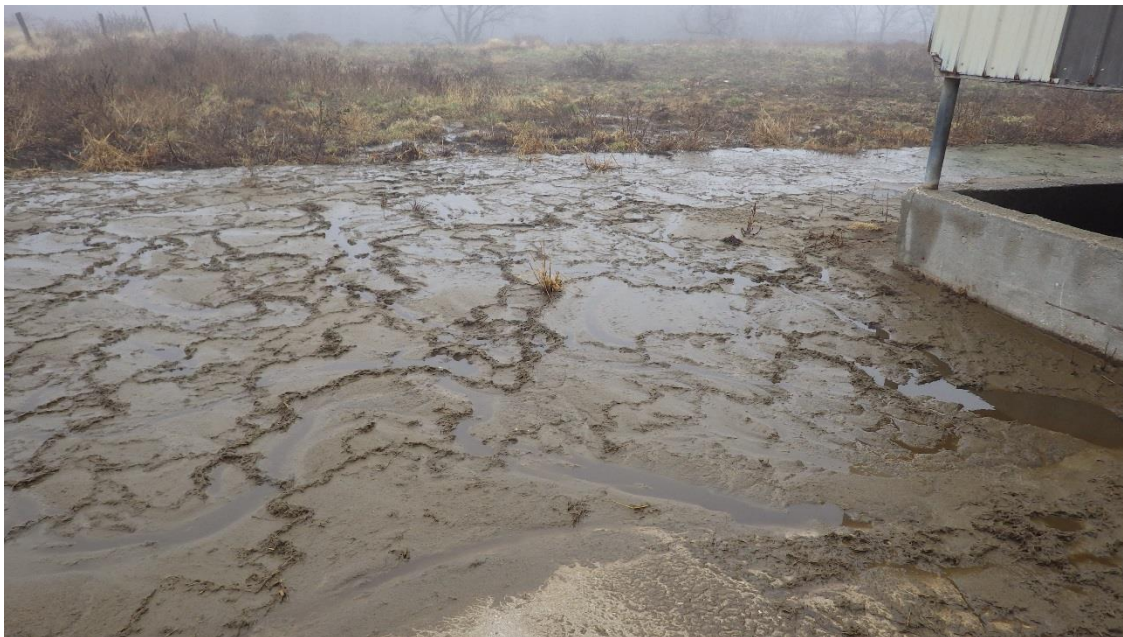
249: RIMG0258

Description: Manure and process wastewater flowed north toward the borrow area from the New Barn and cattle walkways between the New Barn and the barn west of the New Barn.

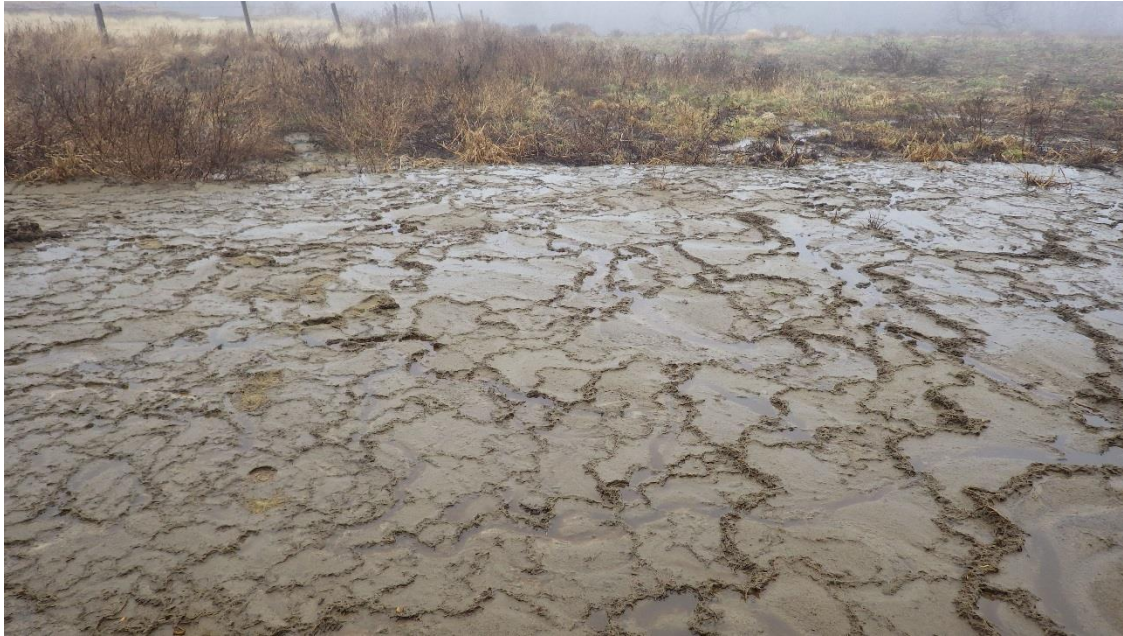
250: RIMG0259

Description: Manure and process wastewater flowed north toward the borrow area from the New Barn and cattle walkways between the New Barn and the barn west of the New Barn.

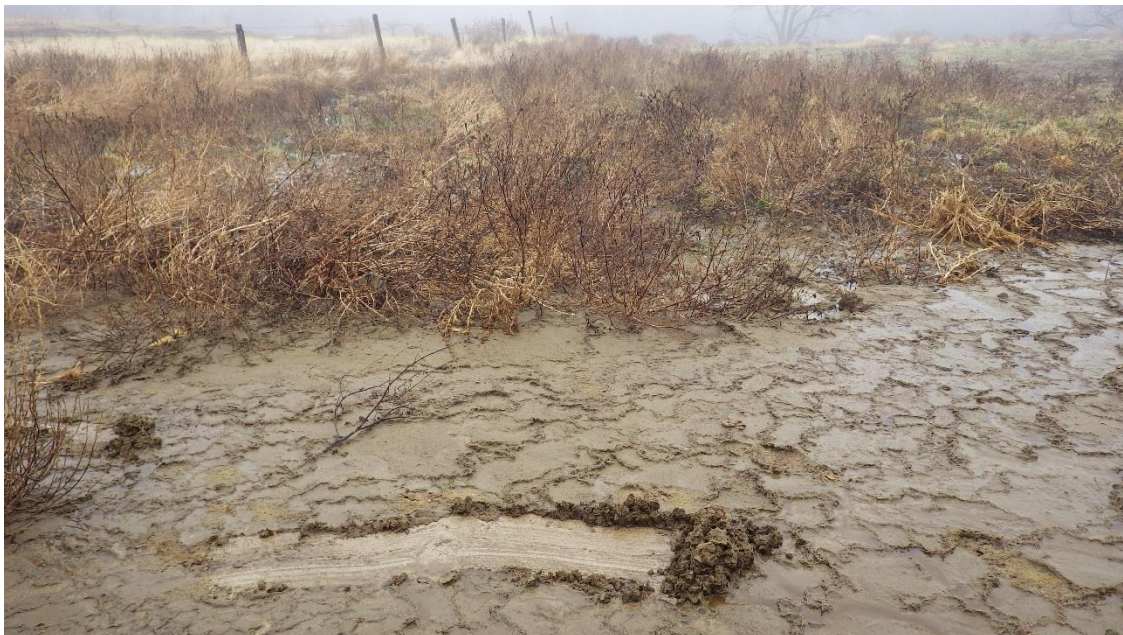
251: RIMG0260

Description: Manure and process wastewater flowed north toward the borrow area from the New Barn and cattle walkways between the New Barn and the barn west of the New Barn.

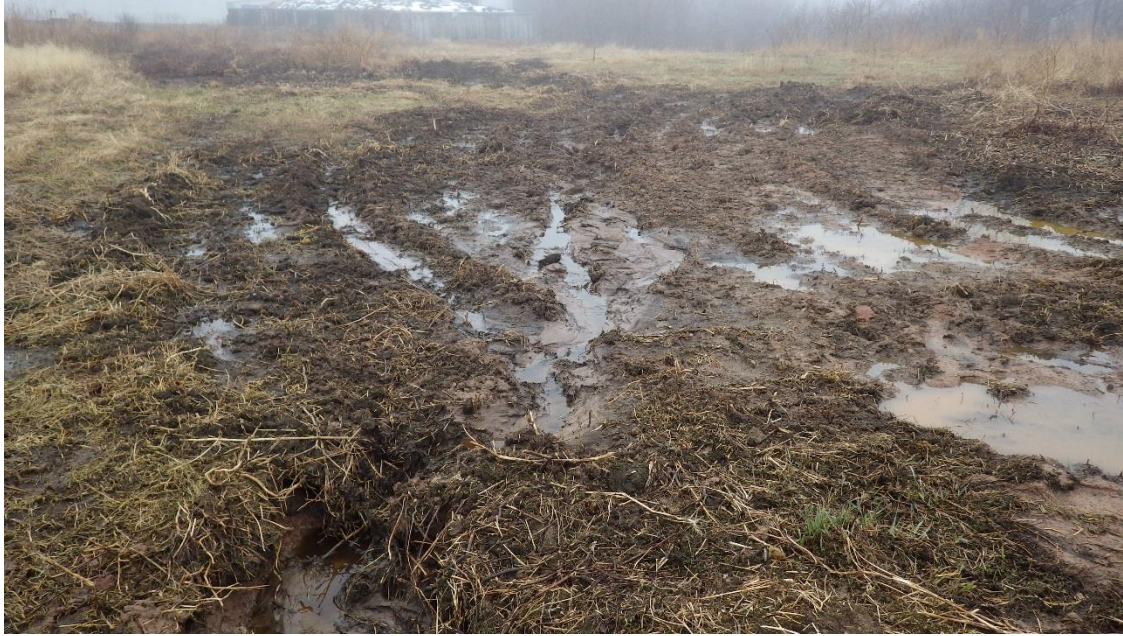
252: RIMG0261

Description: Manure and process wastewater flowed north toward the borrow area from the New Barn and cattle walkways between the New Barn and the barn west of the New Barn.

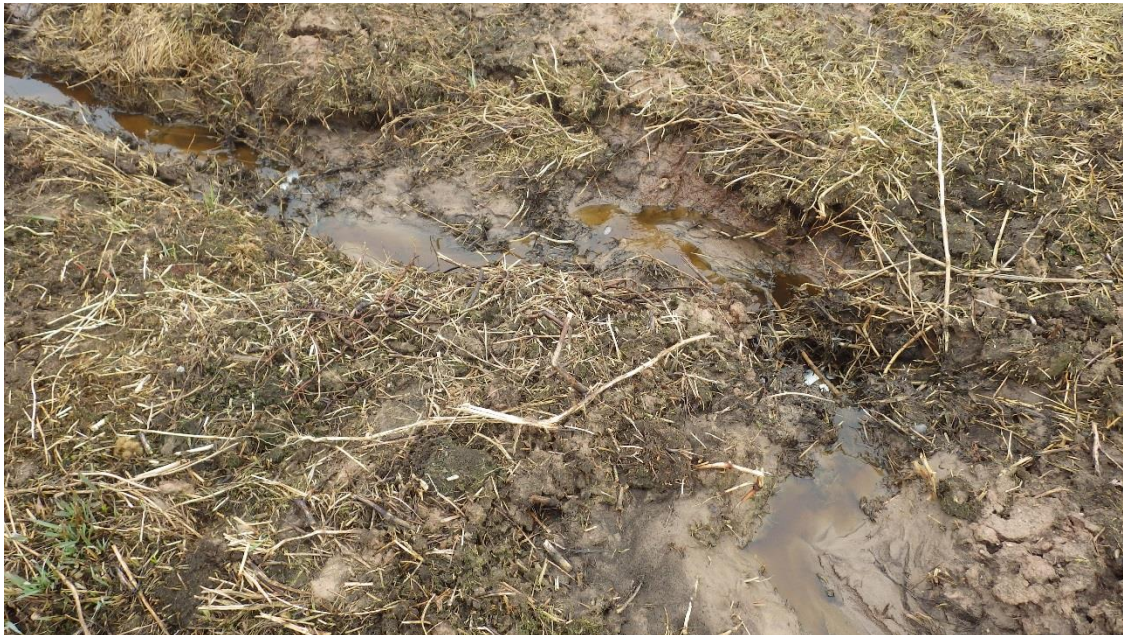
253: RIMG0262

Description: Manure and process wastewater flowed north through the borrow area from the Milk Cow Barn and the access way between the Milk Cow Barn and the feed bunkers.

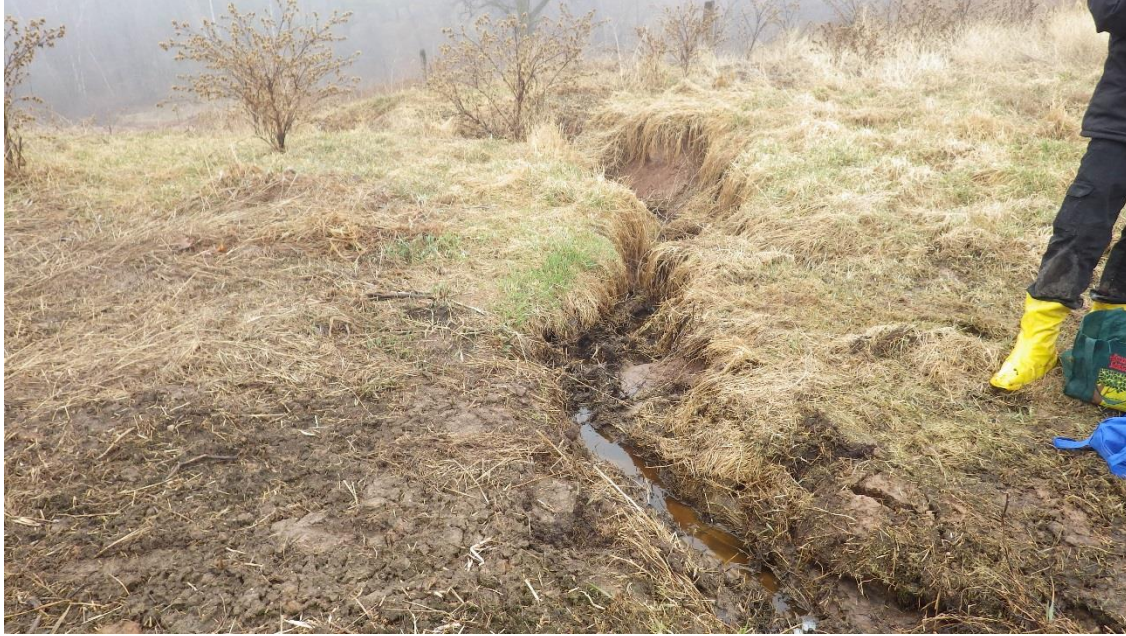
254: RIMG0263

Description: Manure and process wastewater flowed north through the borrow area from the Milk Cow Barn and the access way between the Milk Cow Barn and the feed bunkers.

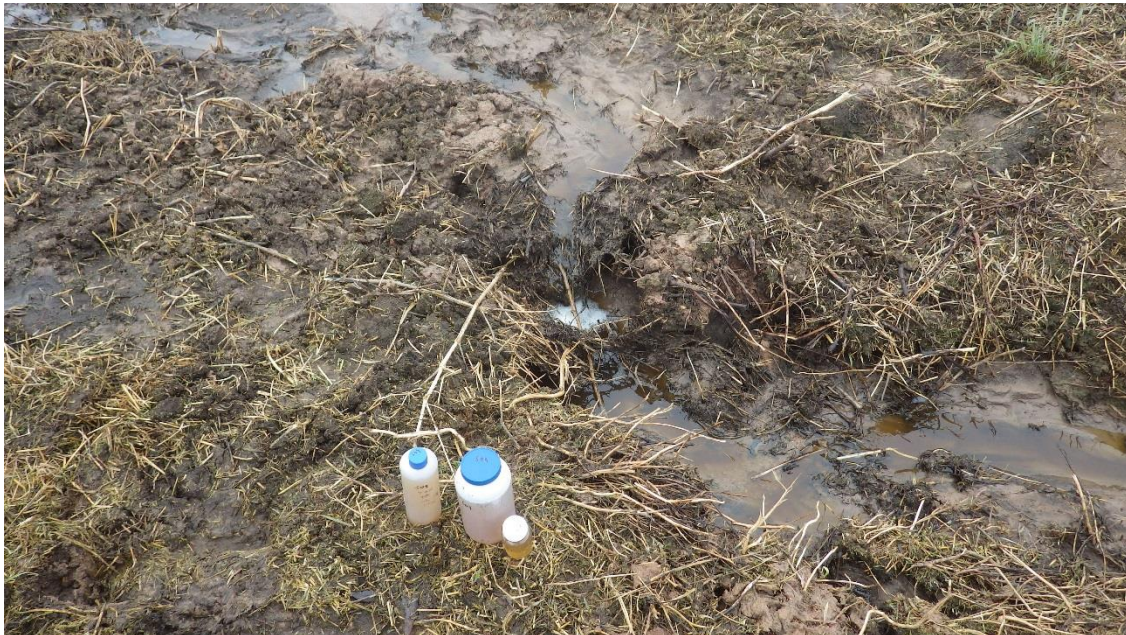
255: RIMG0264

Description: Manure and process wastewater flowed north through the borrow area from the Milk Cow Barn and the access way between the Milk Cow Barn and the feed bunkers.

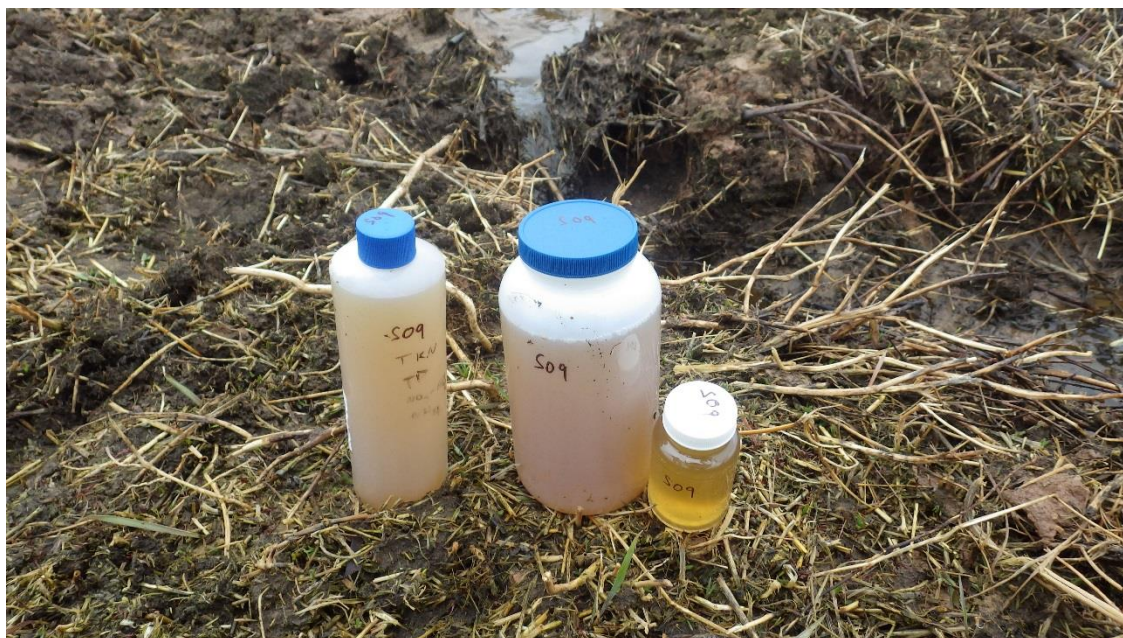
256: RIMG0265

Description: Sample S09 was taken at 1:20 p.m. of manure and process wastewater in a pathway emanating from the Milk Cow Barn and the access way between the Milk Cow Barn and the feed bunkers.

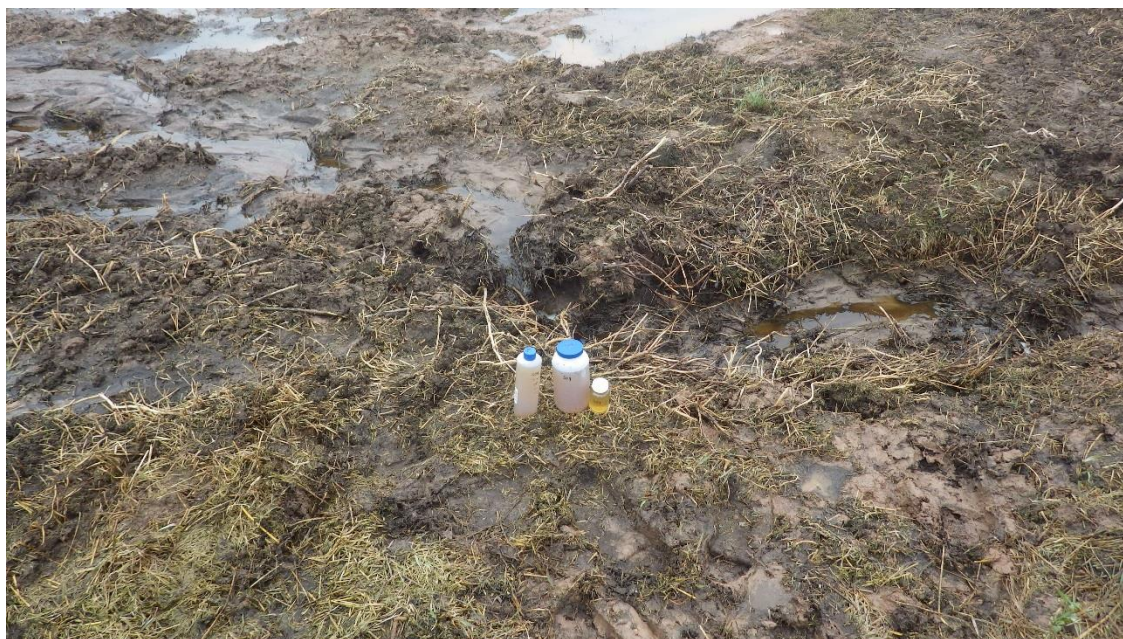
257: RIMG0266

Description: Sample S09 was taken at 1:20 p.m. of manure and process wastewater in a pathway emanating from the Milk Cow Barn and the access way between the Milk Cow Barn and the feed bunkers.

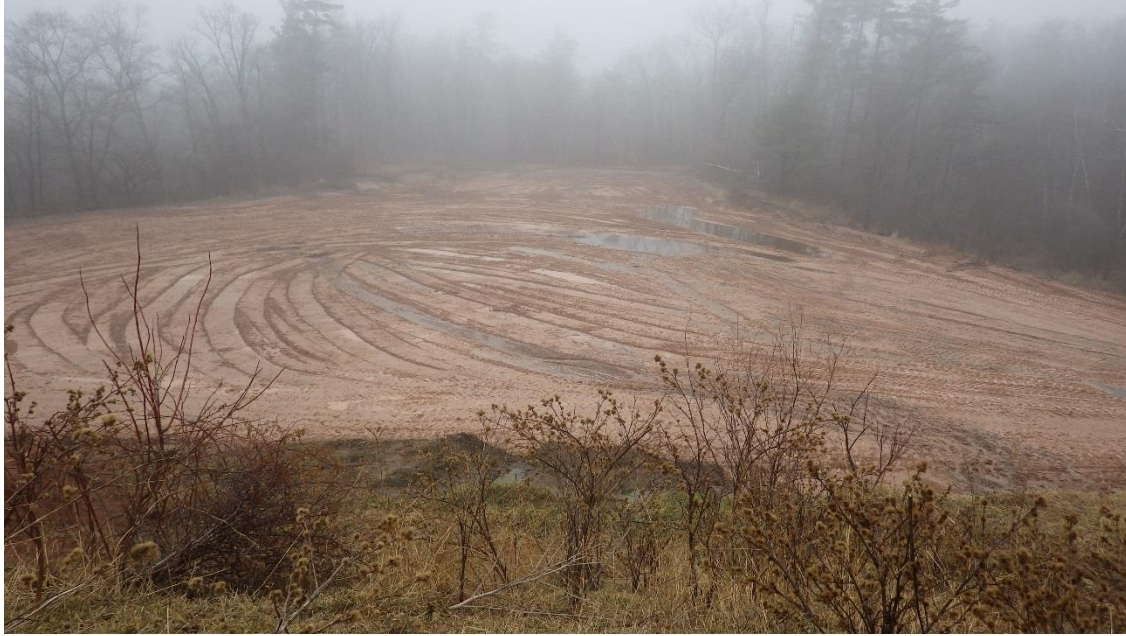
258: RIMG0267

Description: Sample S09 was taken at 1:20 p.m. of manure and process wastewater in a pathway emanating from the Milk Cow Barn and the access way between the Milk Cow Barn and the feed bunkers.

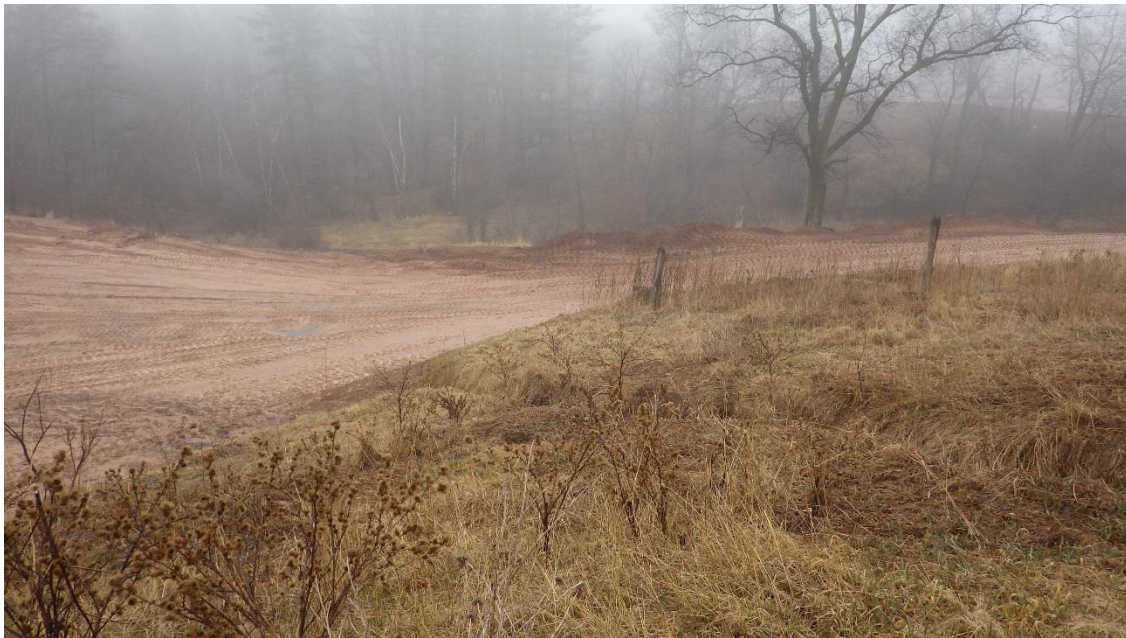
259: RIMG0268

Description: The borrow area did not have sediment and erosion controls installed.

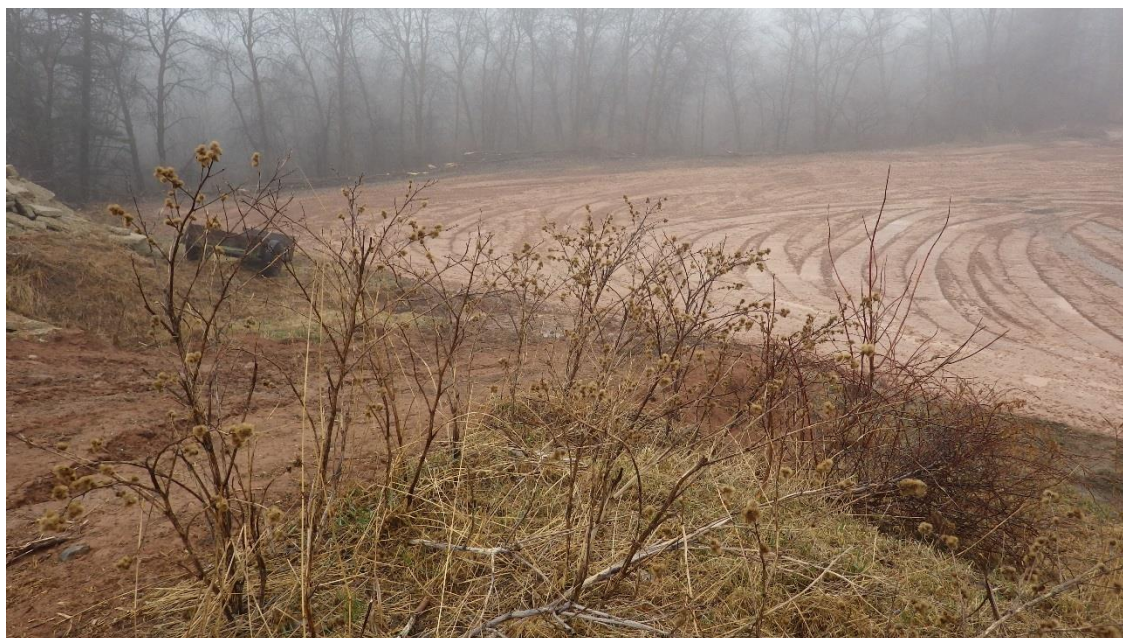
260: RIMG0269

Description: The borrow area did not have sediment and erosion controls installed.

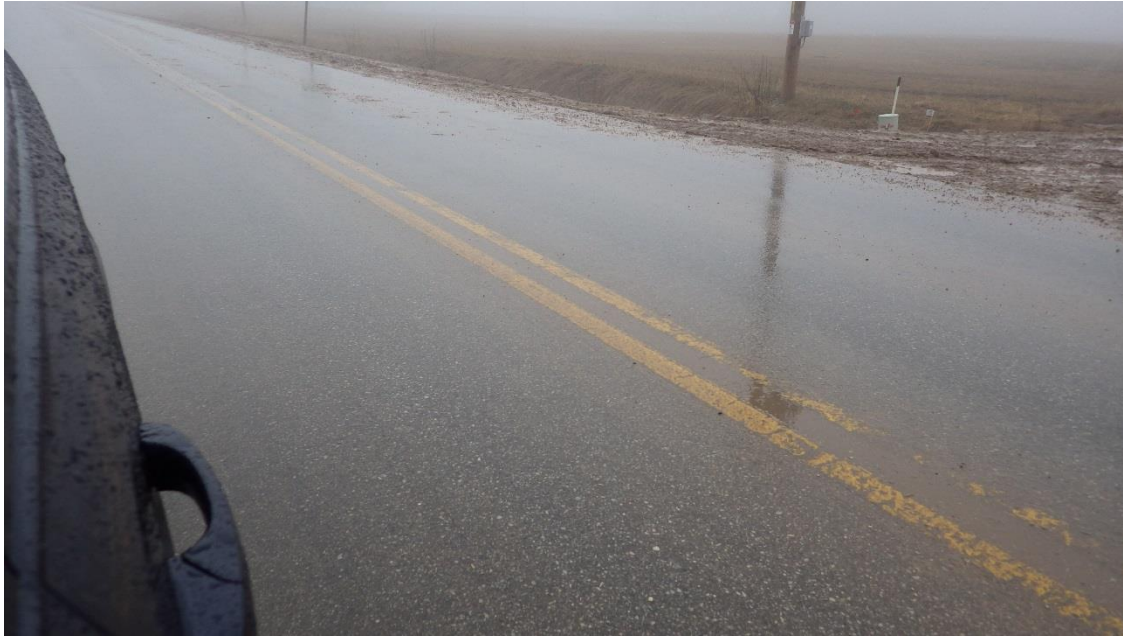
264: RIMG0273  
Description: Sediment had been tracked out onto the south bound lane of County Road V.

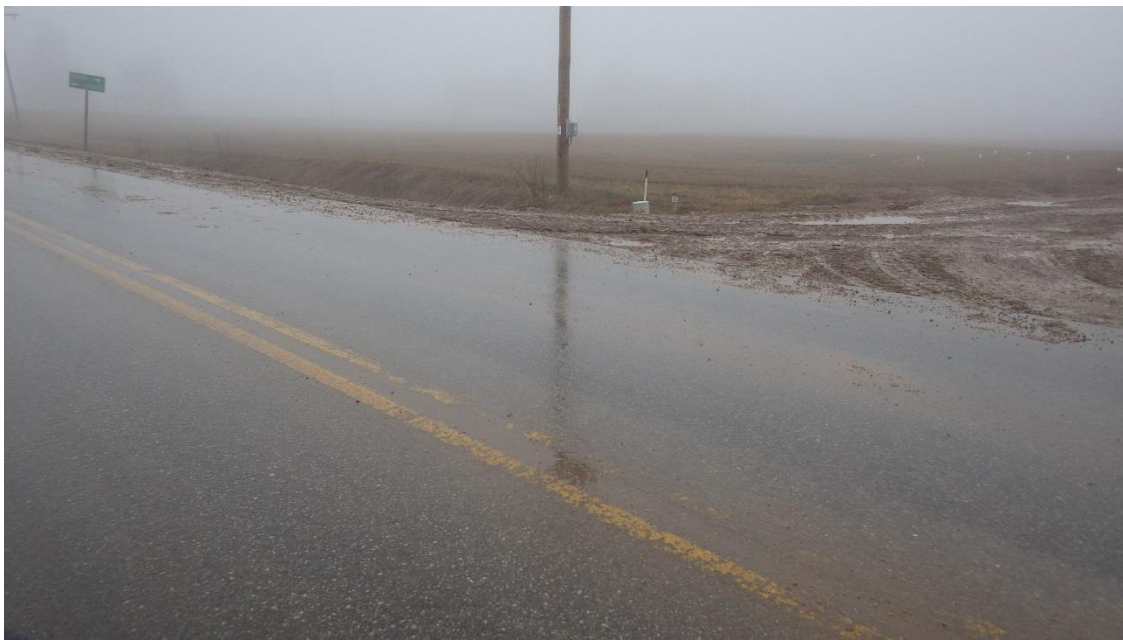
265: RIMG0274

Description: Sediment had been tracked out onto the south bound lane of County Road V.

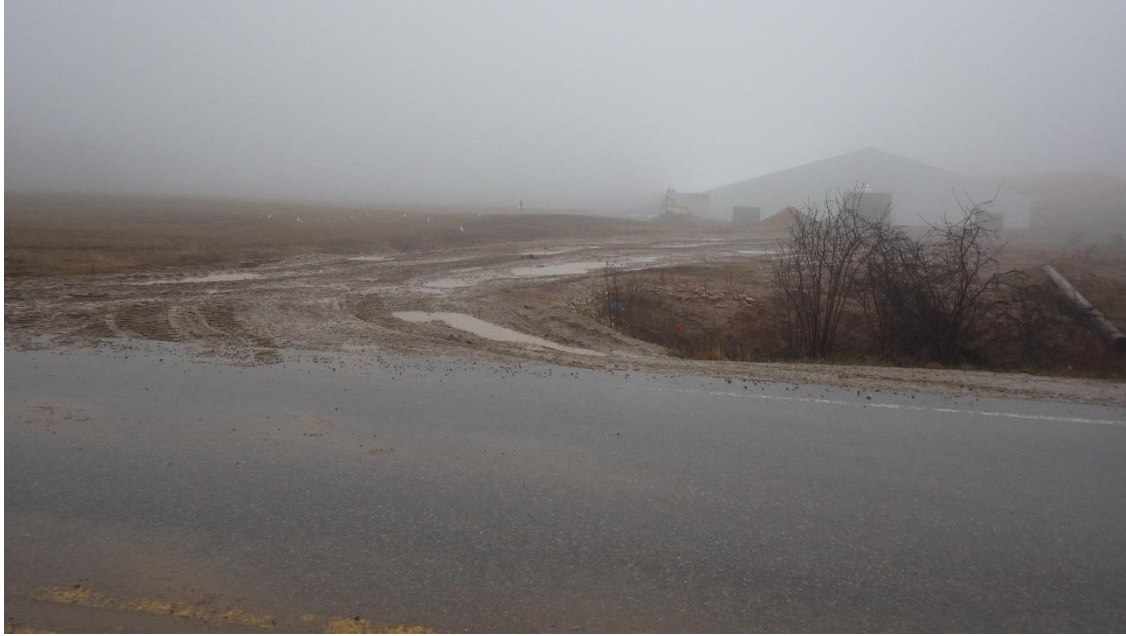
266: RIMG0275

Description: Sediment had been tracked out onto the south bound lane of County Road V.

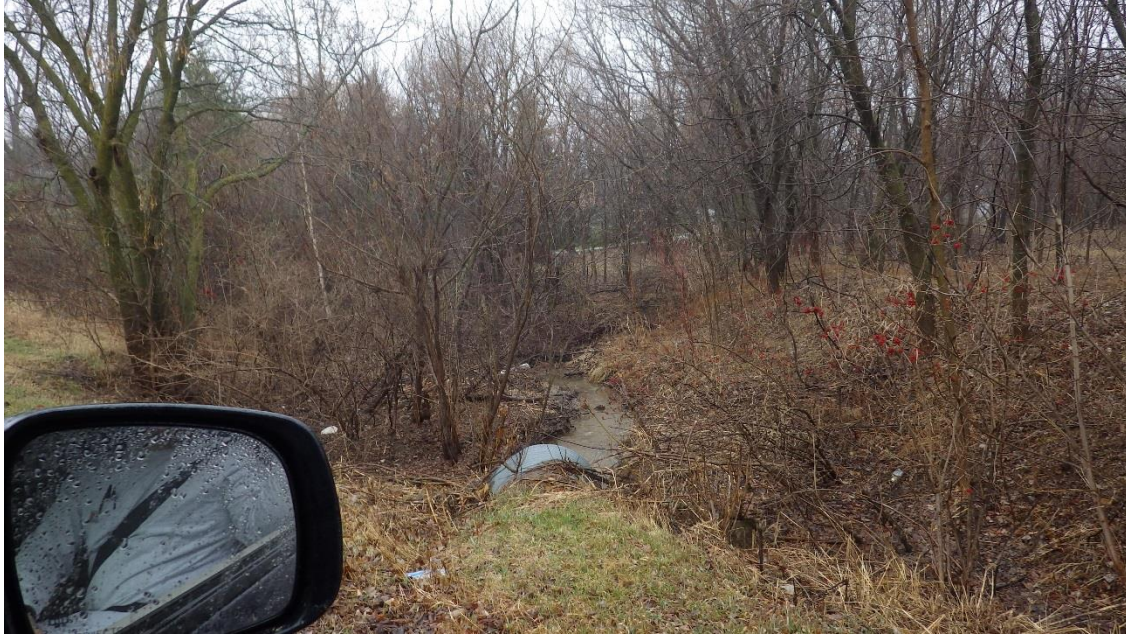
268: RIMG0277

Description: The unnamed tributary had a bed and bank and flow was conveyed via a large culvert under Dollar Road.

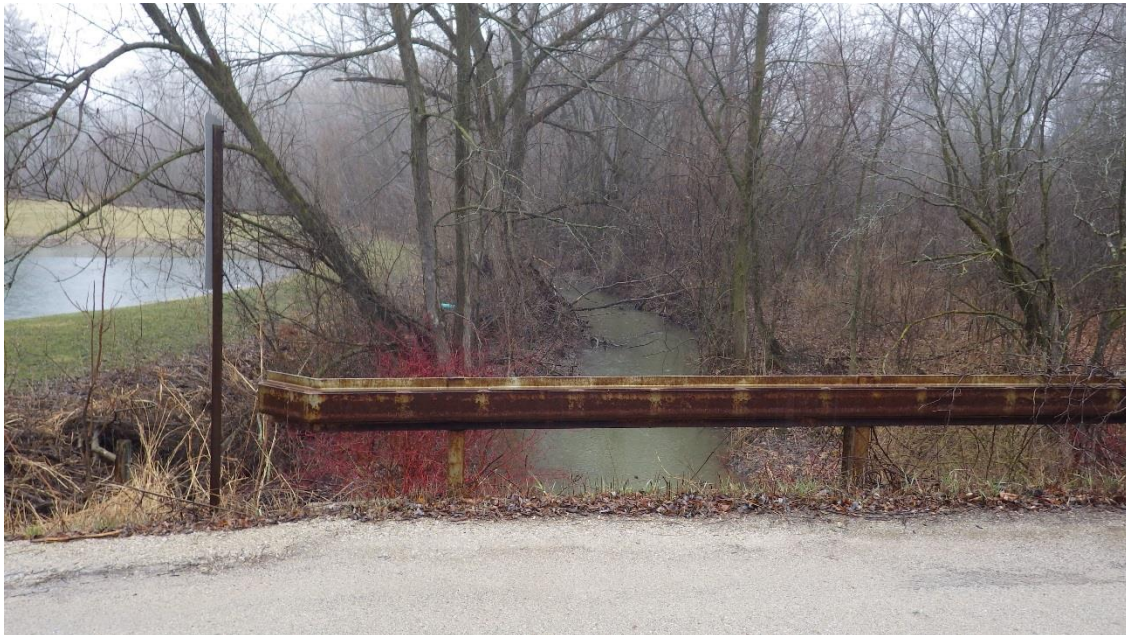
269: RIMG0278

Description: The unnamed tributary had a bed and bank and flow was conveyed via a large culvert under Dollar Road.

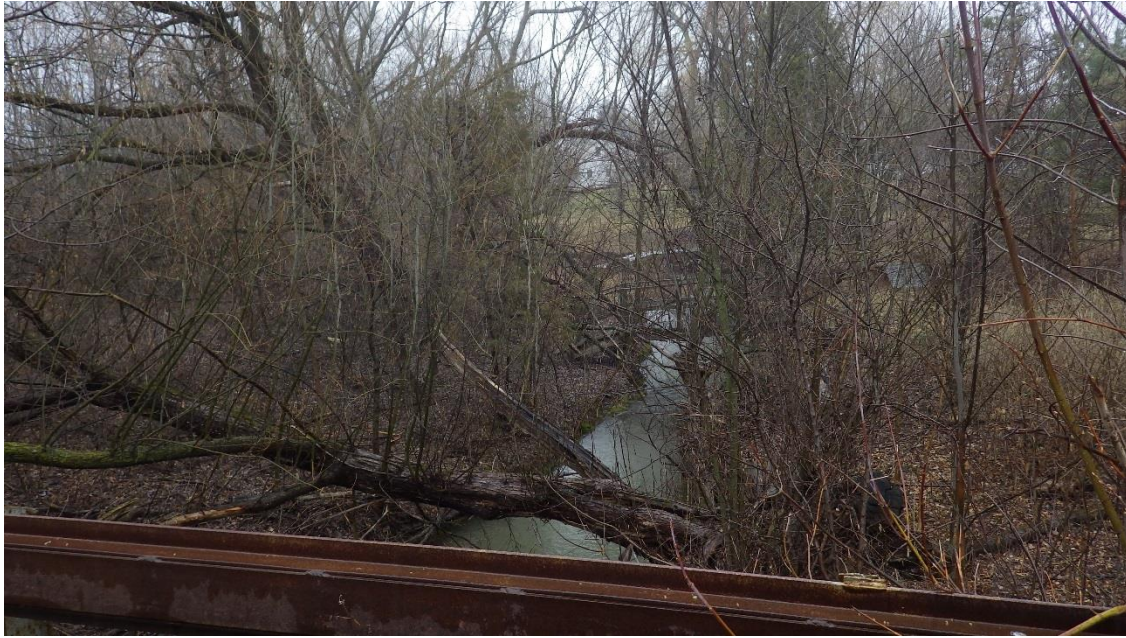
270: RIMG0279

Description: The unnamed tributary had a bed and bank and flow was conveyed under Dollar Road.

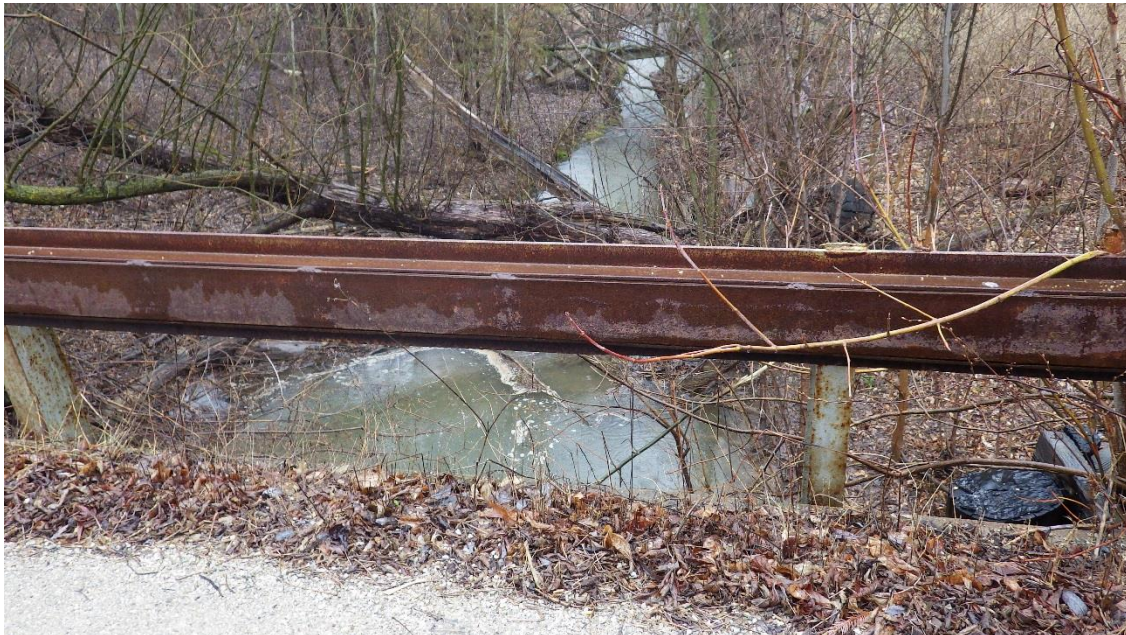
271: RIMG0280

Description: The unnamed tributary had a bed and bank and flow was conveyed under Dollar Road.
